# Appendix P

## Hazardous Materials Phase I Environmental Site Assessment

Phase I Environmental Site Assessment  
SCDOT US 278 Corridor Improvements  
Hilton Head, Beaufort County, South Carolina  
S&ME Project No. 1413-18-001  
KCI Project No. 251800390

Reference: **Phase I Environmental Site Assessment**  
SCDOT US 278 Corridor Improvements  
Beaufort County, South Carolina  
S&ME Project No. 1413-18-001

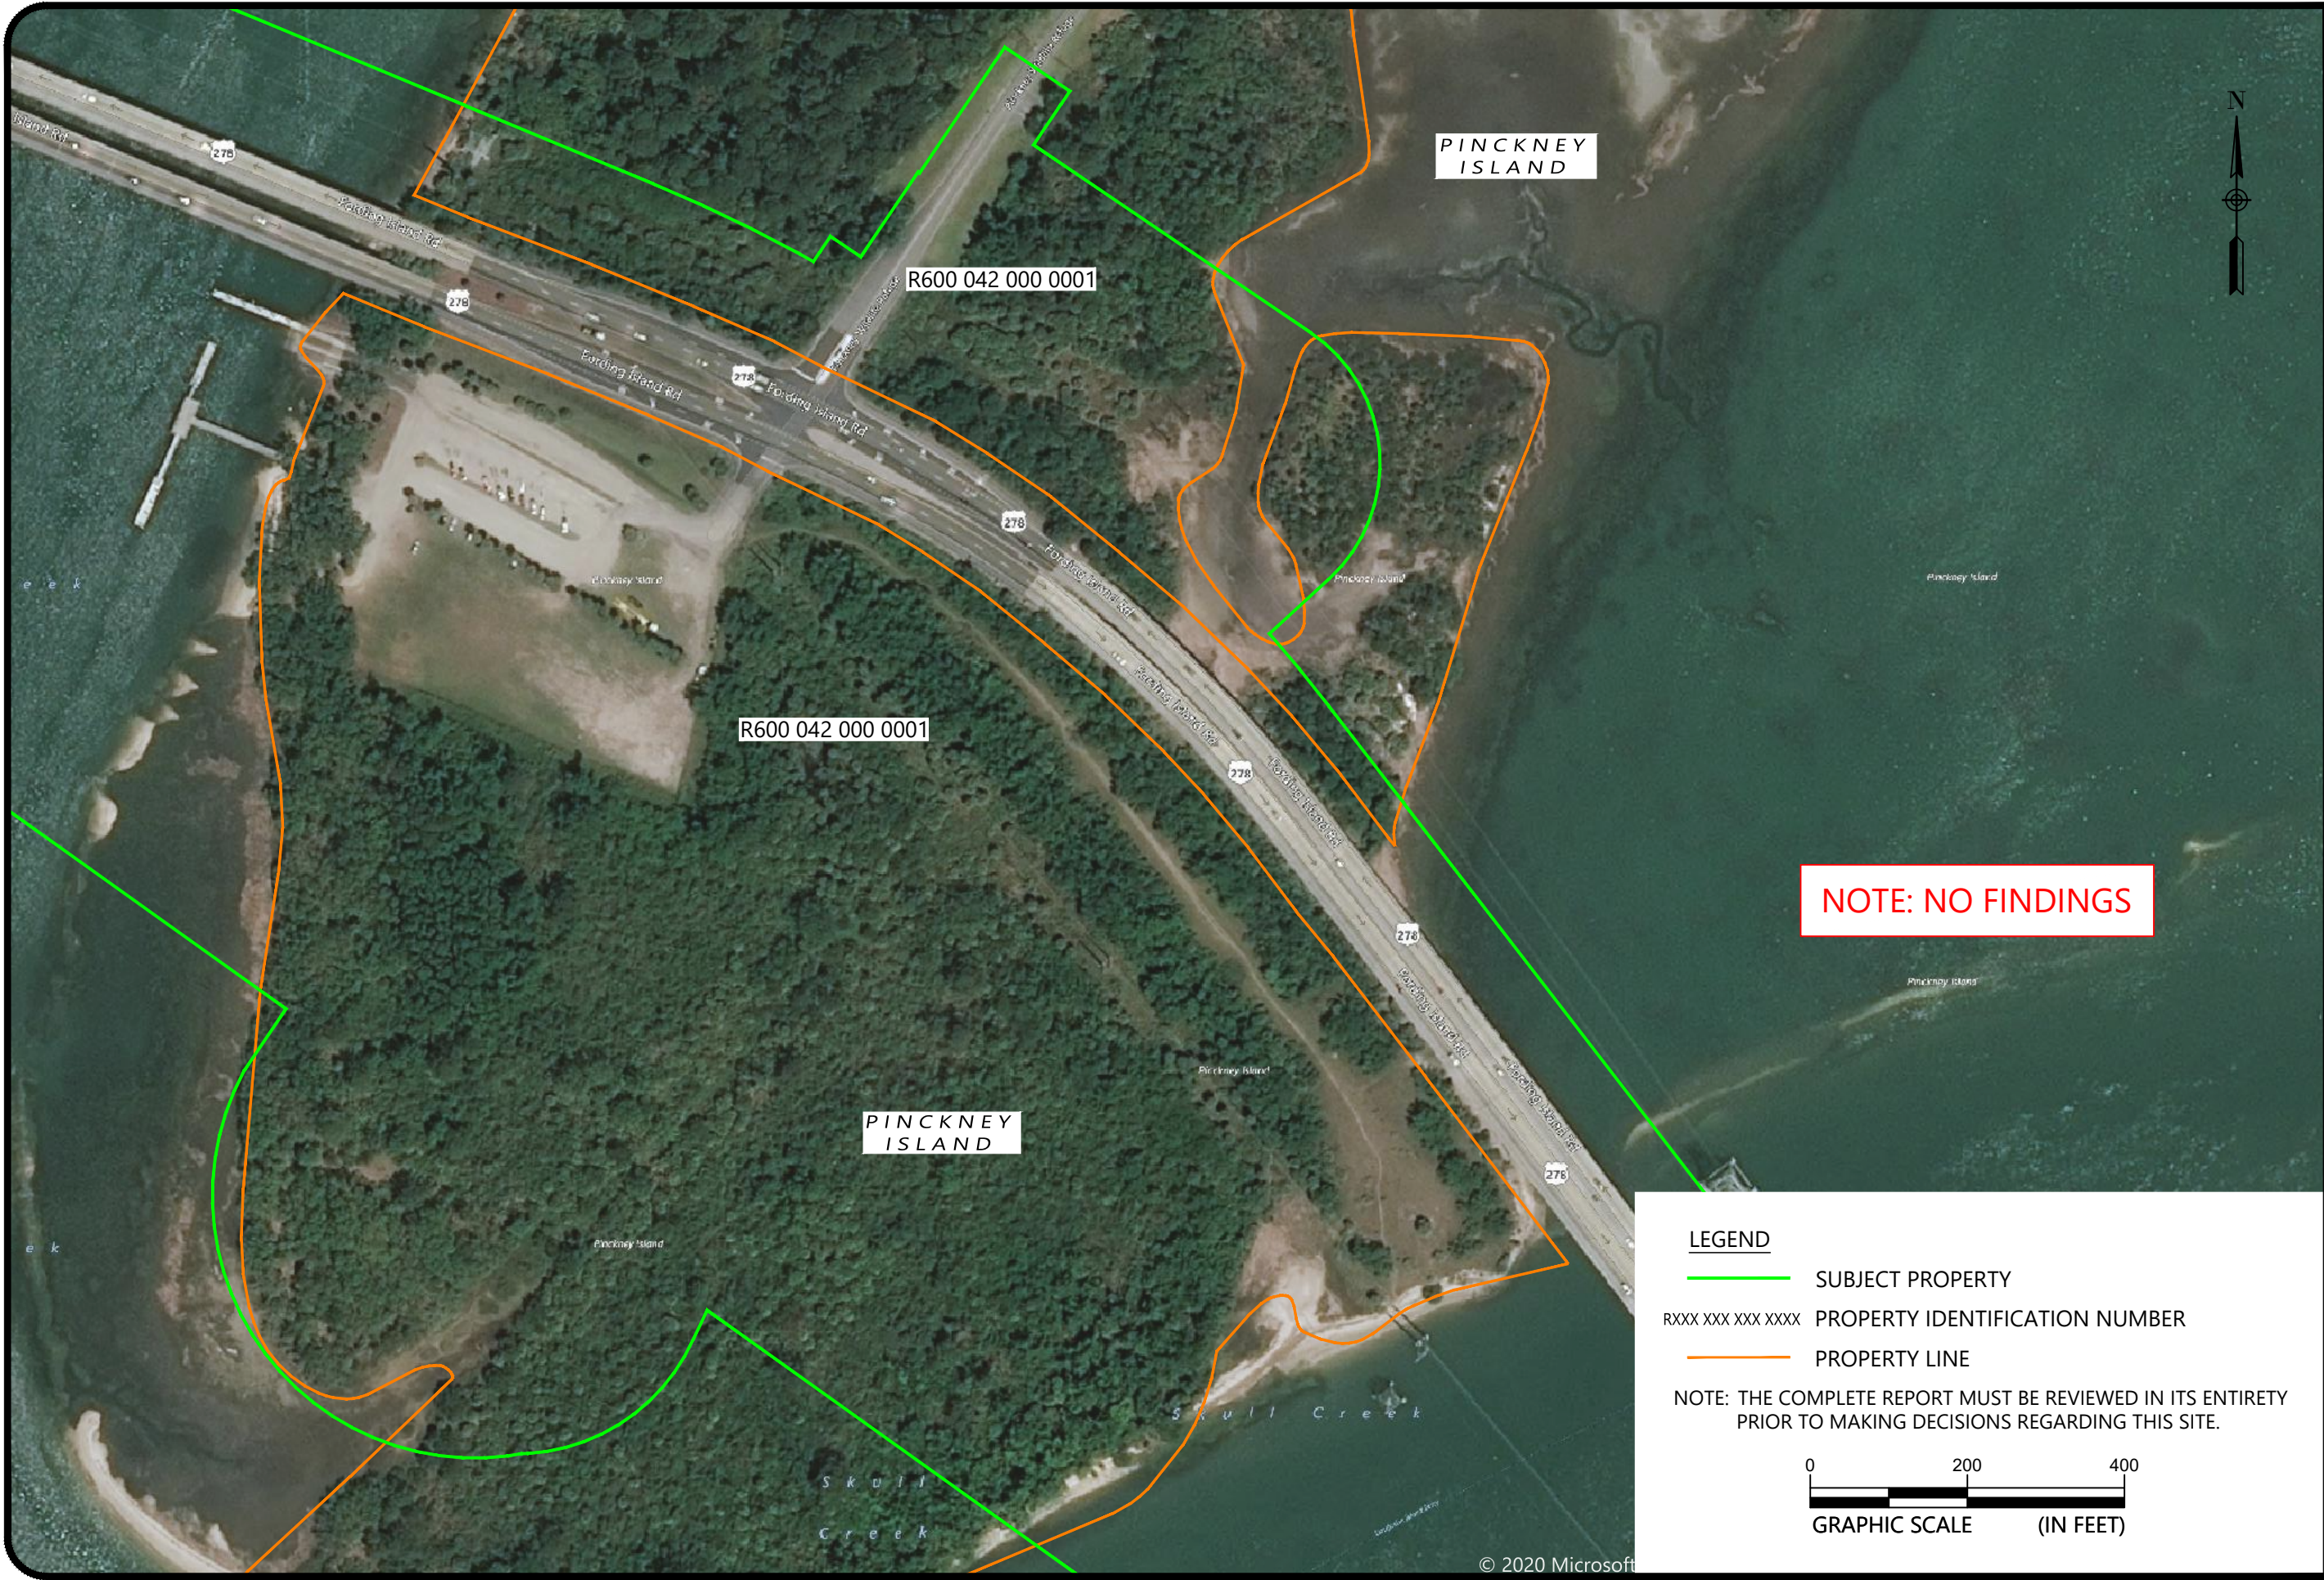
<b>PHASE I ENVIRONMENTAL SITE ASSESSMENT FINDINGS</b>	
PHASE I ENVIRONMENTAL SITE ASSESSMENT US HIGHWAY 278 CORRIDOR BLUFFTON - HILTON HEAD, SOUTH CAROLINA	
SCALE:	AS SHOWN
DATE:	7-01-2020
PROJECT NUMBER	1413-18-001
FIGURE NO.	4
