Preliminary Jurisdictional Determination

Beaufort County, South Carolina

Preliminary Jurisdictional Determination Package

US 278 Corridor Improvements
Preliminary
Jurisdictional Determination
Beaufort County, SC

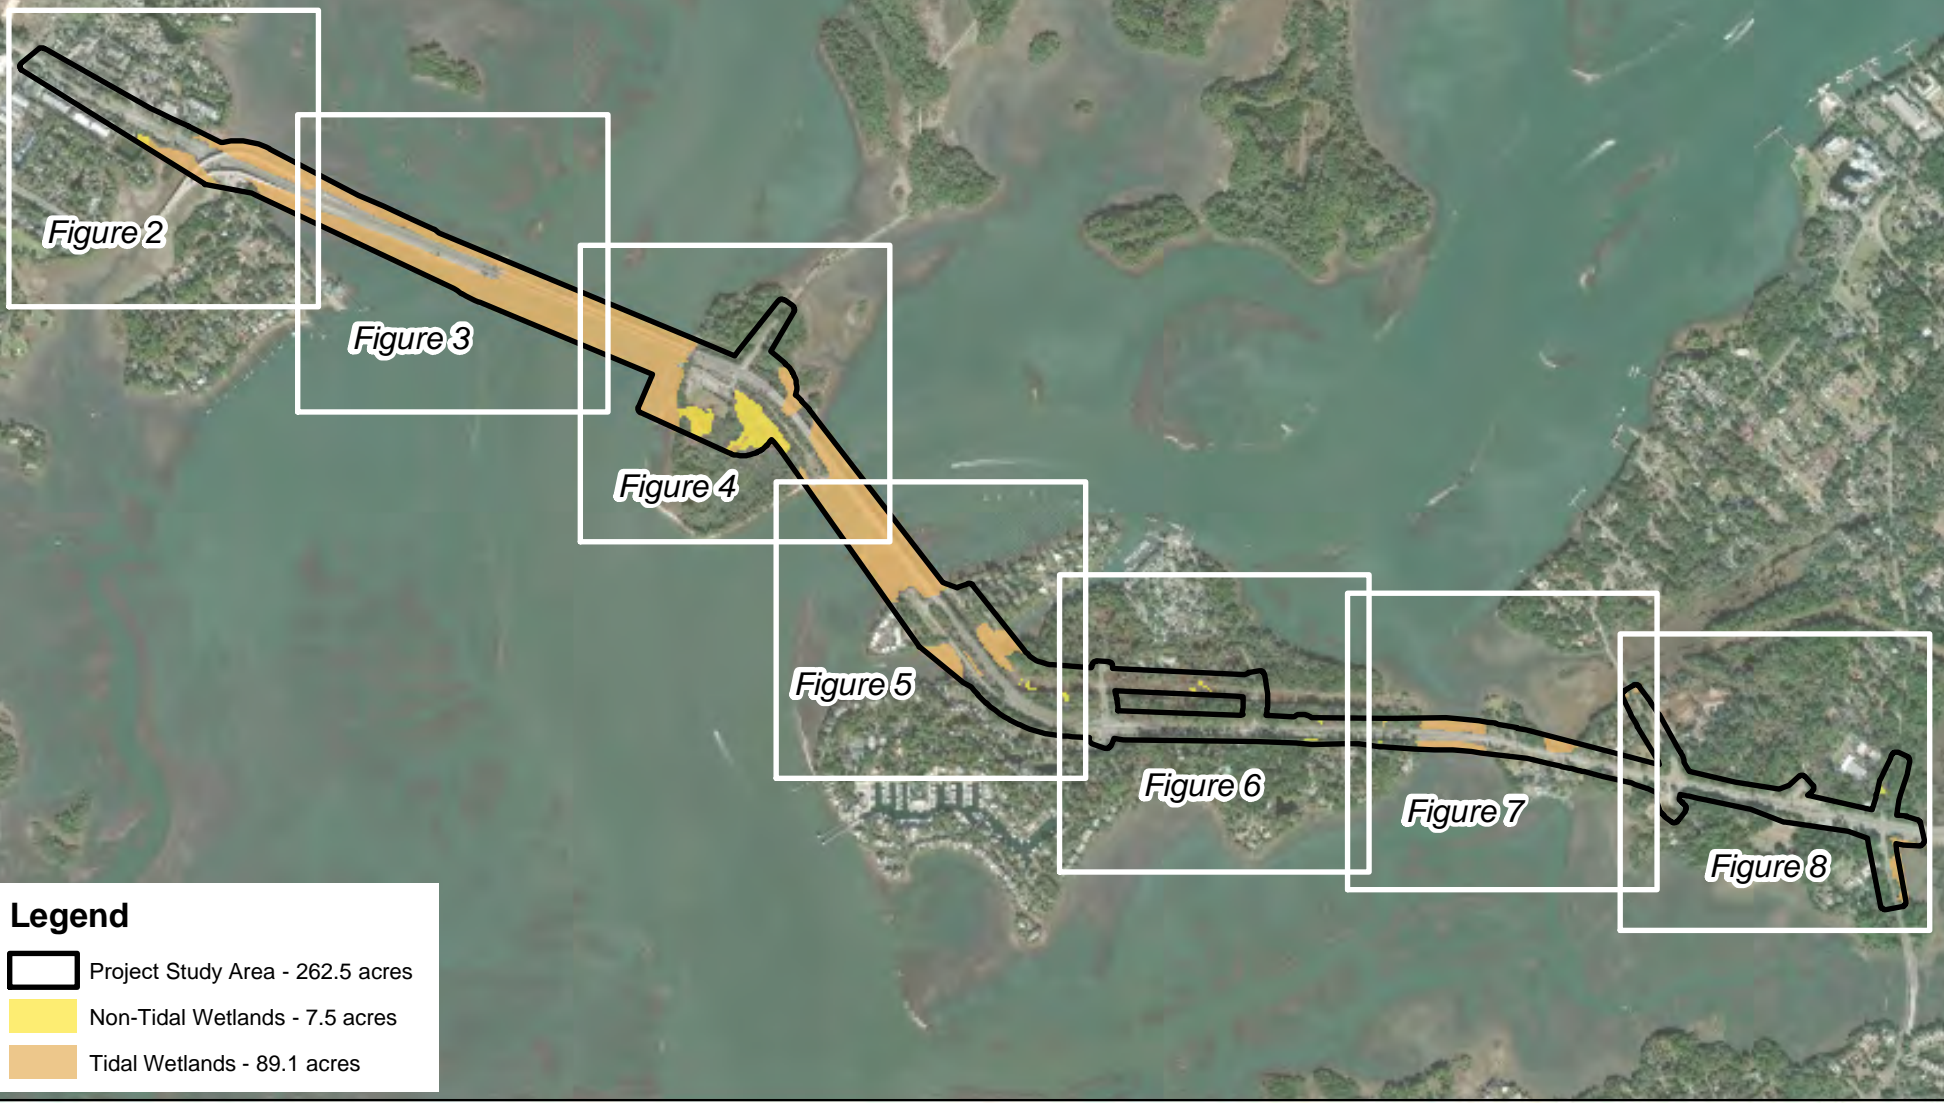
Figure 1

Delineated Features

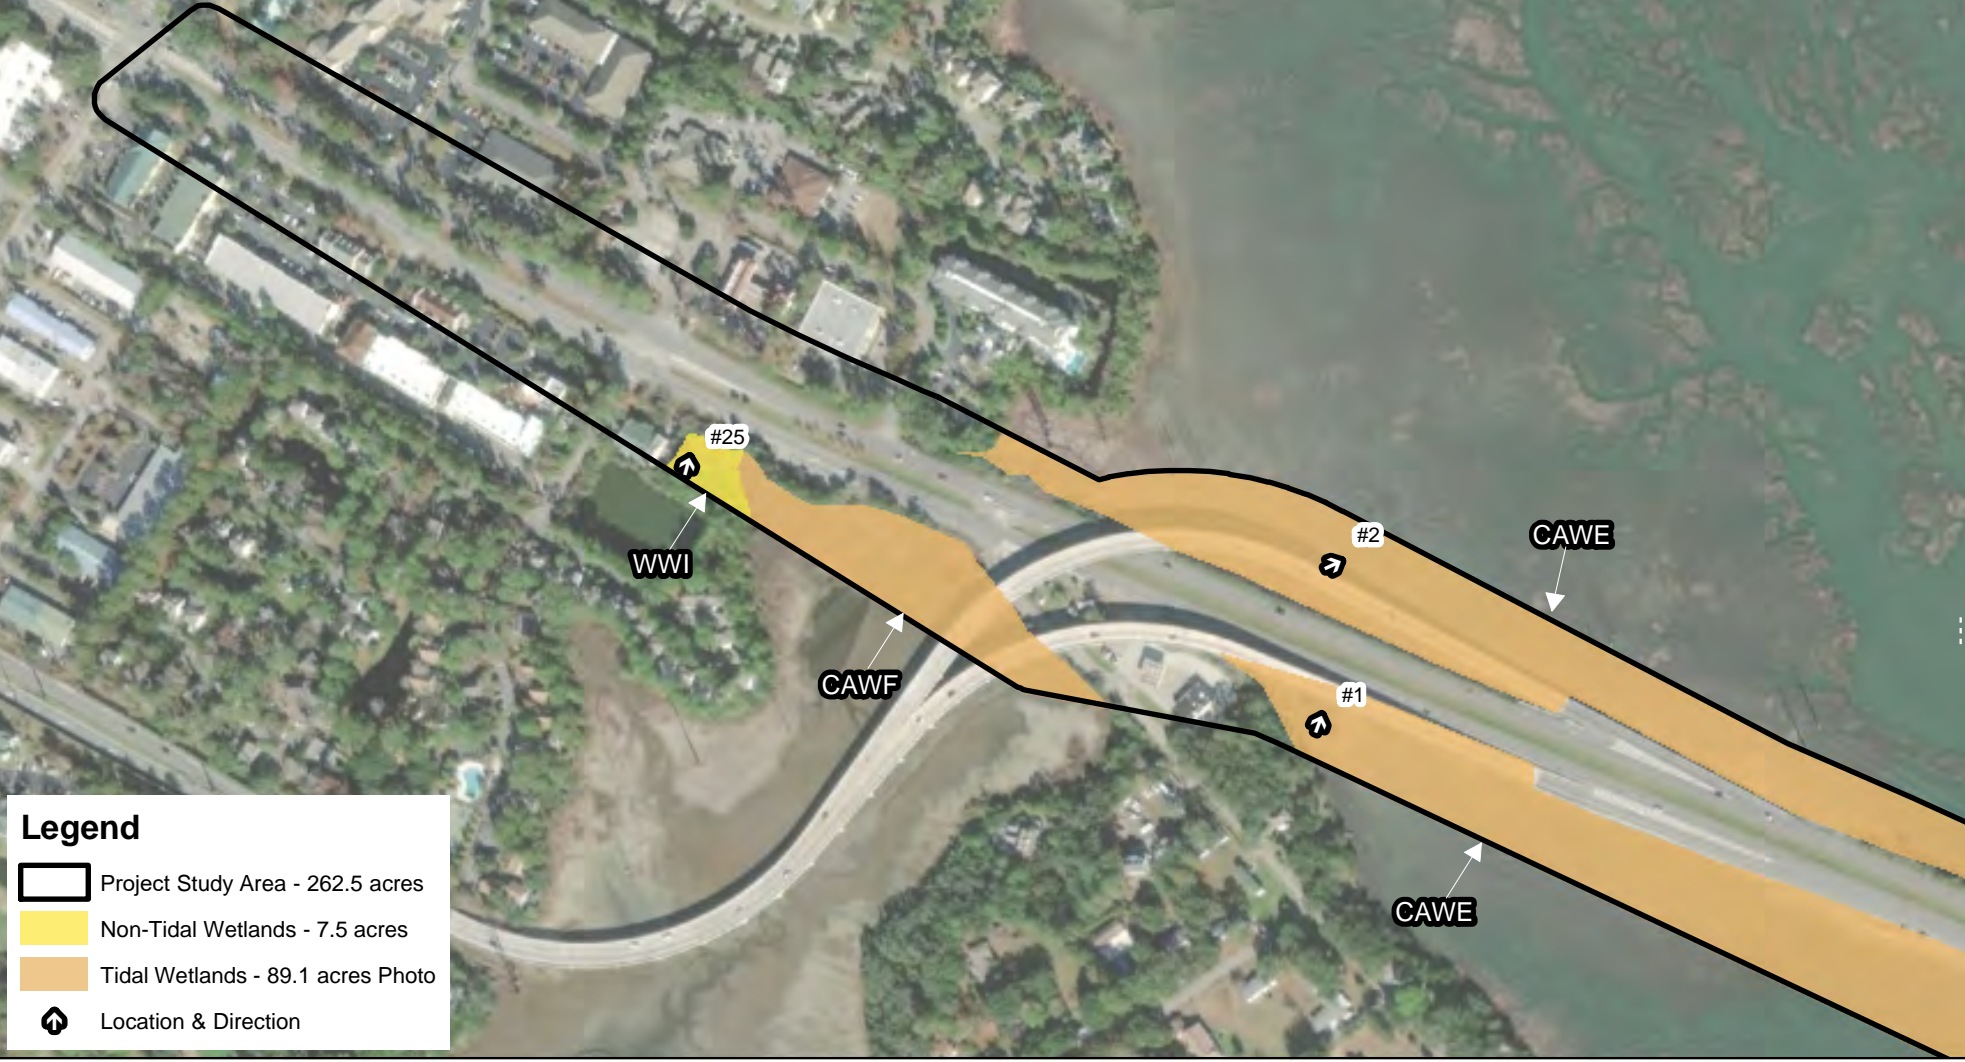
Figure 2

- Project Study Area - 262.5 acres
- Non-Tidal Wetlands - 7.5 acres
- Tidal Wetlands - 89.1 acres Photo
- Location & Direction

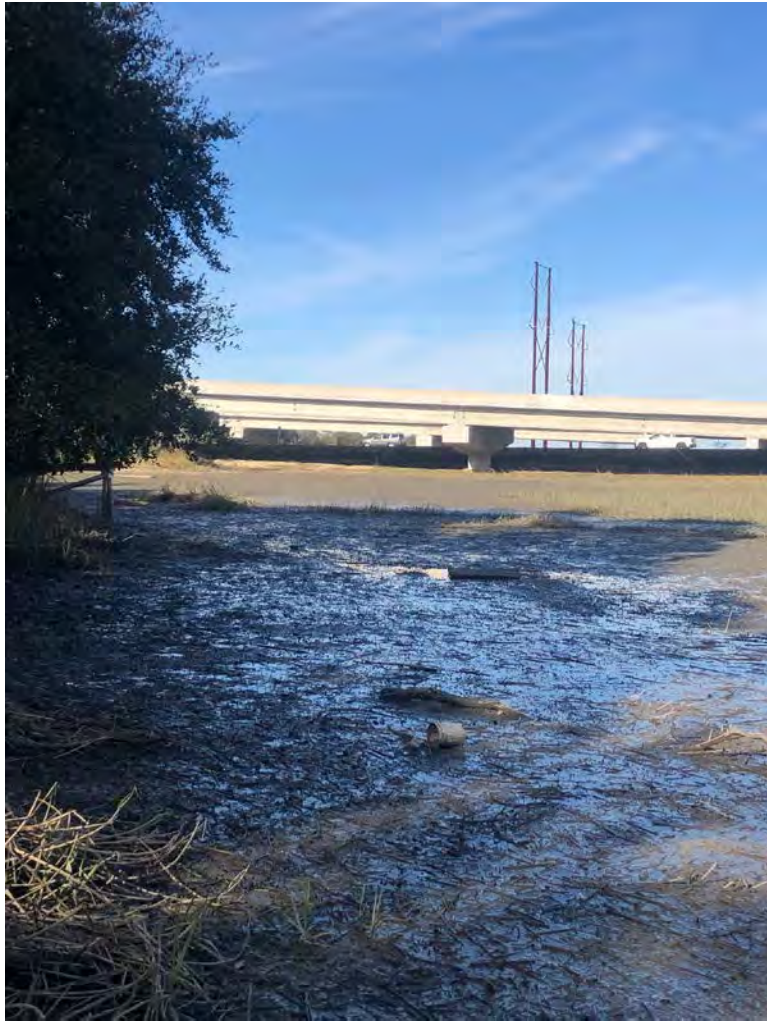
Photo #1

CAWE, facing US 278 and Bluffton Pkwy ramp
(32.233728, -80.801883)

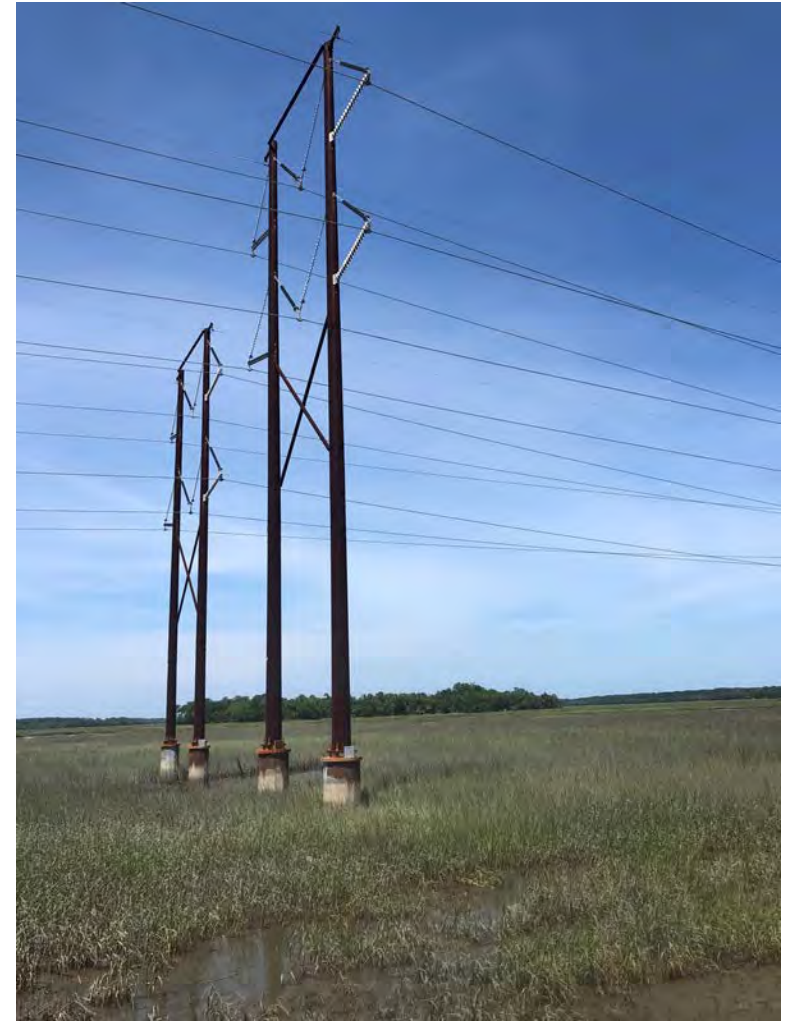
Photo #2

CAWE, north of US 278
(32.234634, -80.80178)

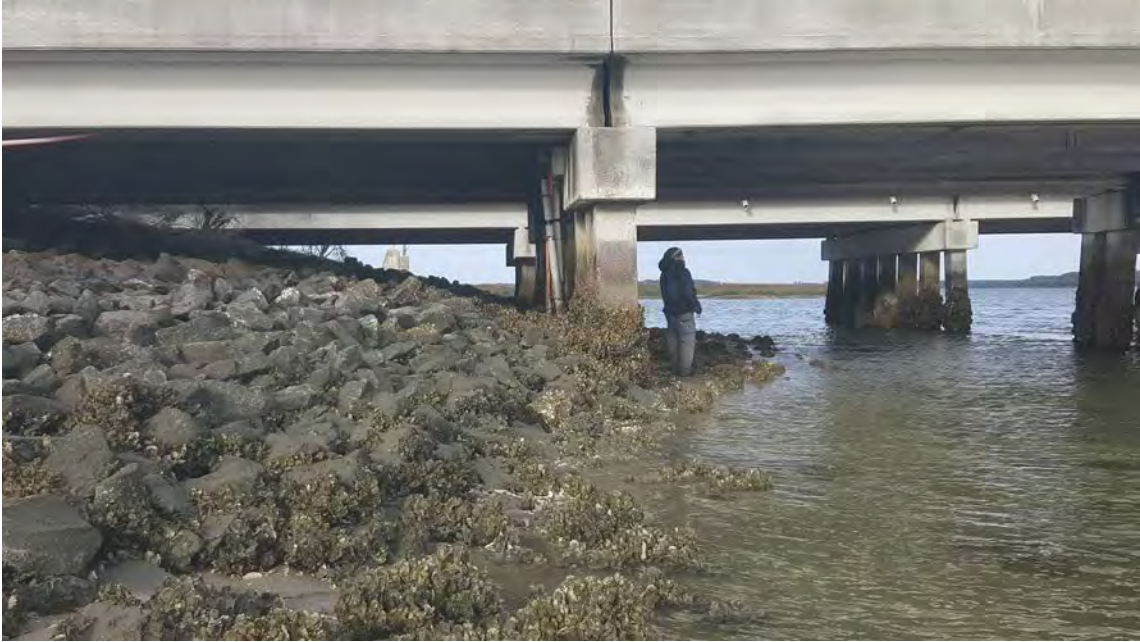
Photo #3

CAWE, facing beneath US 278 bridge
(32.231095, -80.794091)

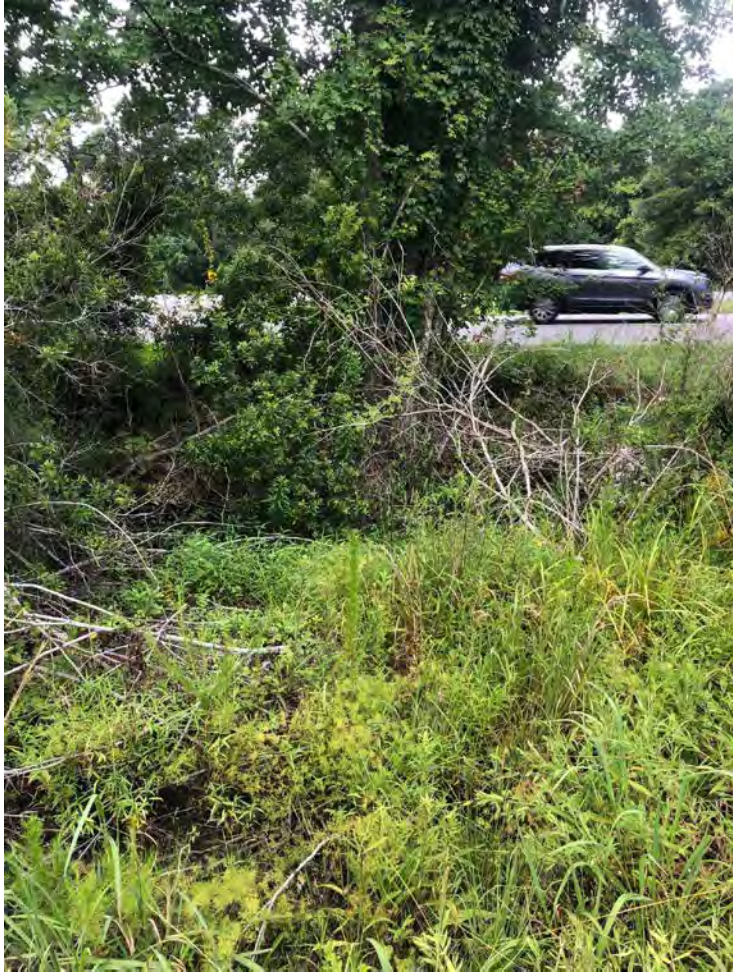
Photo #17

WWG meets roadside ditch, north of US 278
(32.219521, -80.77651)
